TECHNICAL BULLETIN	Series	IMSA / USAC
		Page	1/1
		Date	3/11/26

Subject: Mustang Dark Horse R Front Caliper Grub Screw:

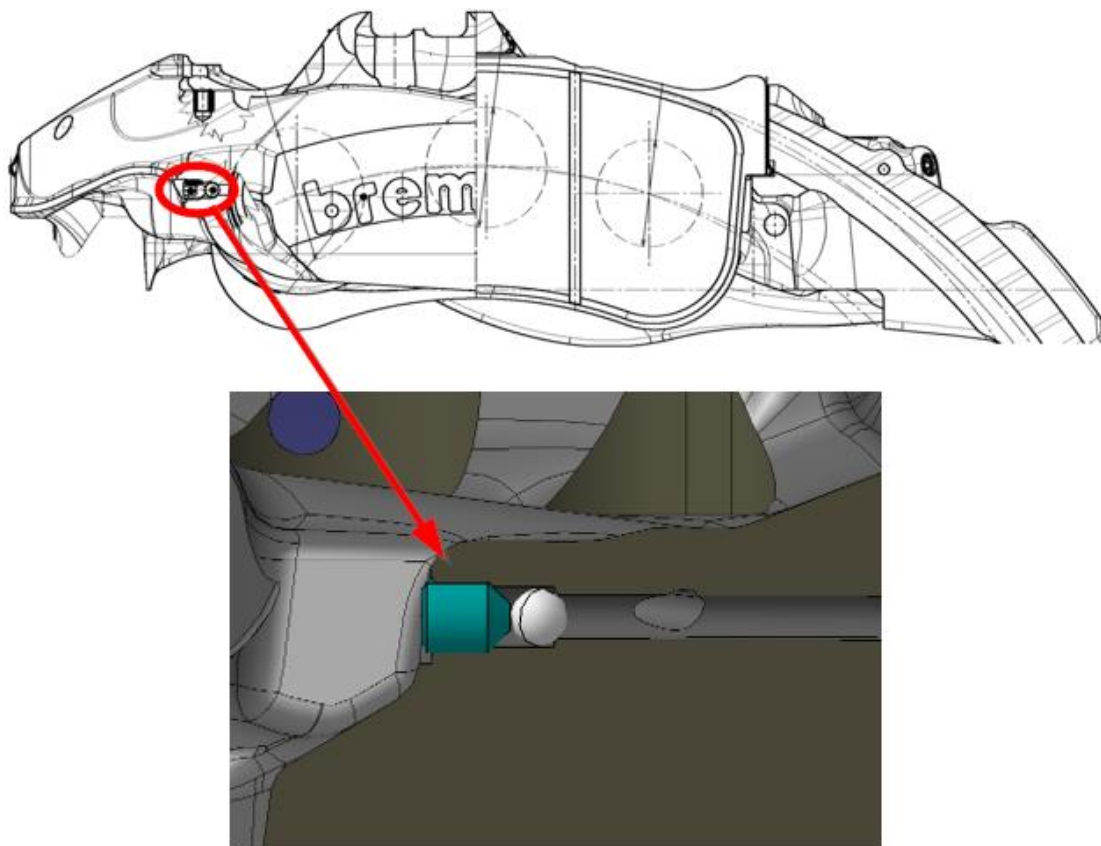
This bulletin is intended to highlight the grub screws located in six places on the front brake calipers of the Mustang Dark Horse R.

In some cases, a dust may accumulate around the screw area. This is especially apparent on the top of the caliper. This is typically caused by excess permanent thread lock used during assembly, which can remain on the external surface of the caliper body and attract dust. This condition is cosmetic only and does not indicate a problem with the caliper.

These screws must not be adjusted, loosened, or tightened under any circumstances. They are factory-installed permanent components and are not to be manipulated.

Using a hex key or any other tool on these screws may alter the factory torque and/or damage the screw. Doing this can damage the caliper and may result in a fluid leak, which will render the caliper unusable.

No action is required. Do not manipulate these screws.
